████████████████████
Evaluation report (24-month report)

Testing of ██████████ products in a 3- year outdoor exposure in Greece using cladding- and block- tests

Research Committee, TEI of Thessaly (former Larissa)
Project no. 3749

KARDITSA, GREECE (June 2013)

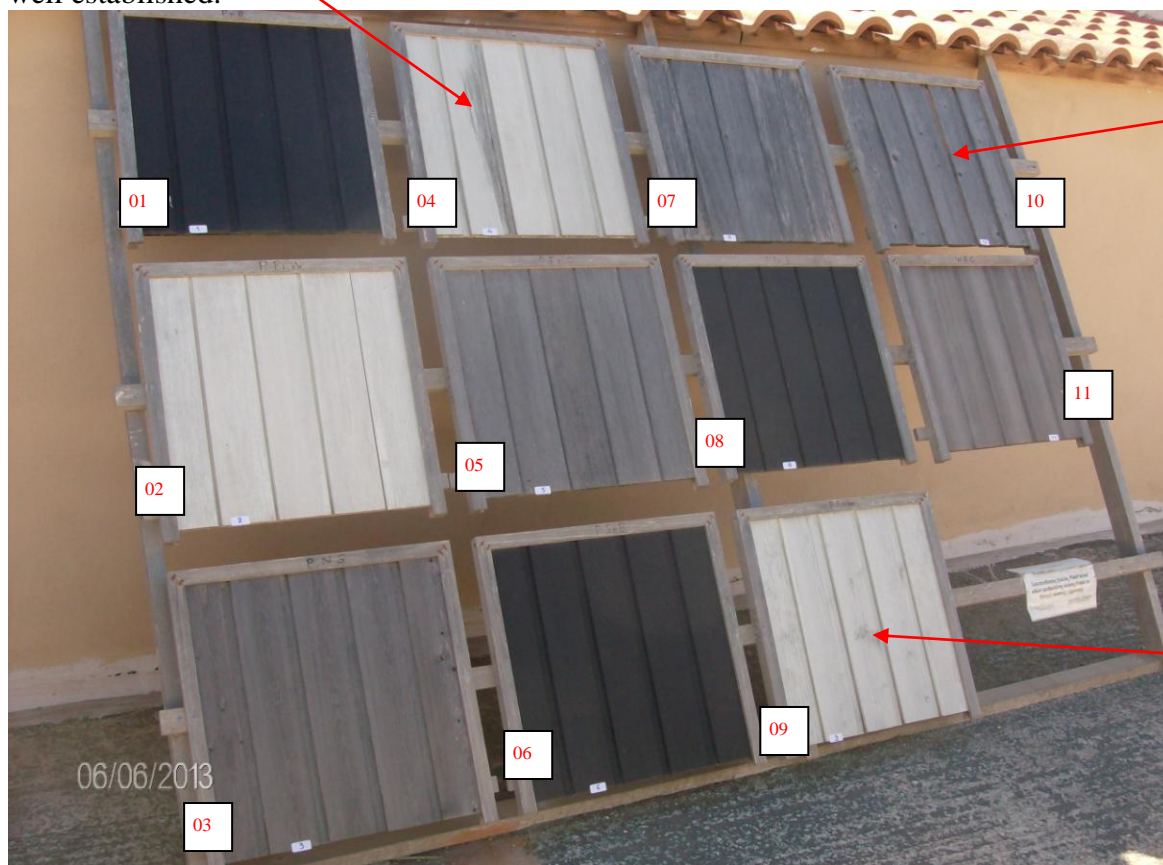
Fig. 1. Cladding test area of the testing materials (as in **June 2013**); white-painted XXX samples having some discolouration (no. 04, 09), especially no. 04, while the control sample no. 10 looks very weathered and is highly distorted. The black-coloured claddings, no. 08, 01, 06 behave the best so far in the experiment, as well as the control WRC (no. 11).

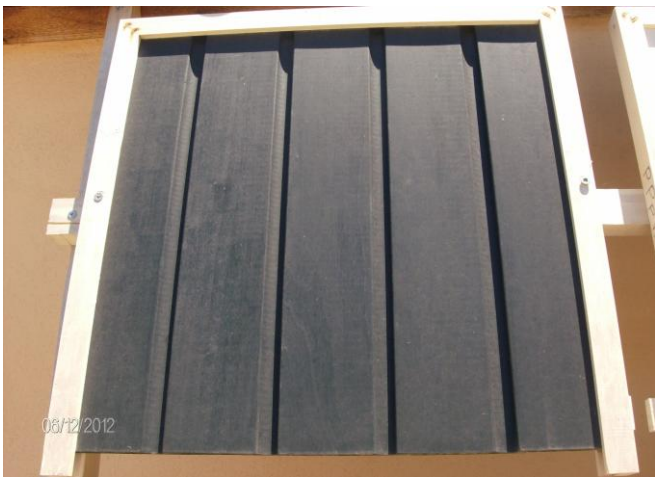
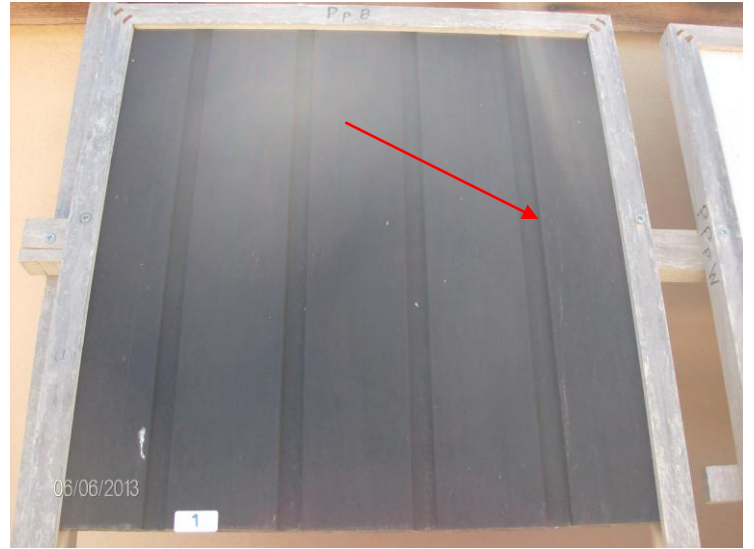
Fig. 5. Cladding 01: XXX Poplar Black, as in June 2012; The same 01 as in **June 2013**; looks good in colour stability.

Cladding 01 is in a very good condition, with a stable colour; a slight uprising in a plank of the cladding (red arrow) appears to happen. The edges of cladding 01 are quite closed.

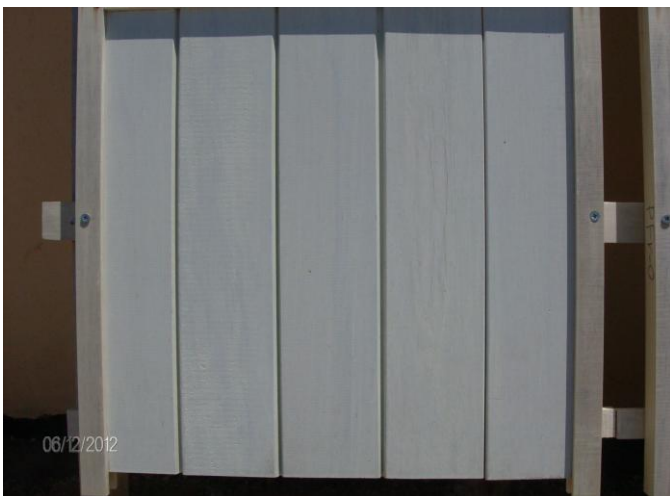
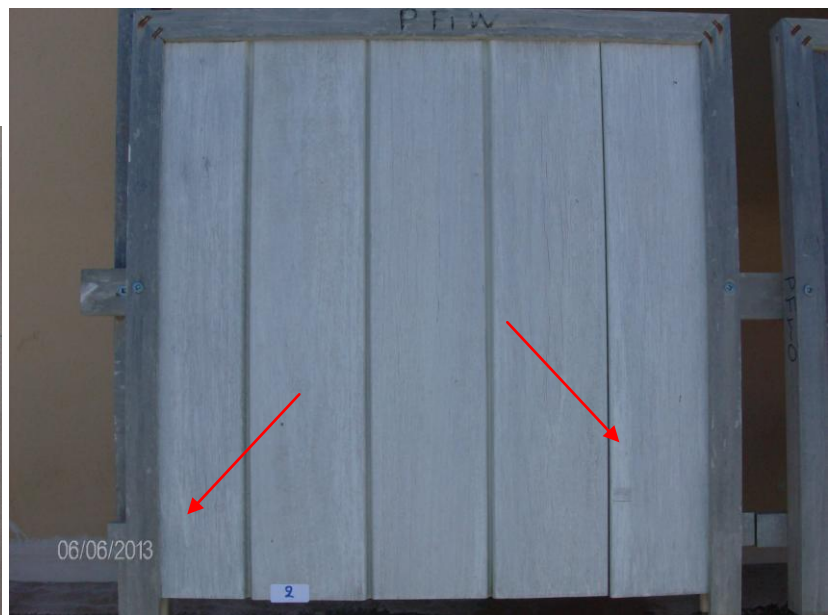
Fig. 6. Cladding 02: XXX Frake White, as in June 2012; The same cladding 02 as in **June 2013**

Cladding 02 is in a relatively good condition, with a slightly stable colour; the smooth and shiny surface appearance is not there as one year ago; some type of colour fading (red arrows) appeared. The edges of the cladding are quite closed. Locally in the surface of cladding no. 02, a number of small checks has appeared on it. It is the best cladding of the 3 White-painted XXX claddings used in the project.

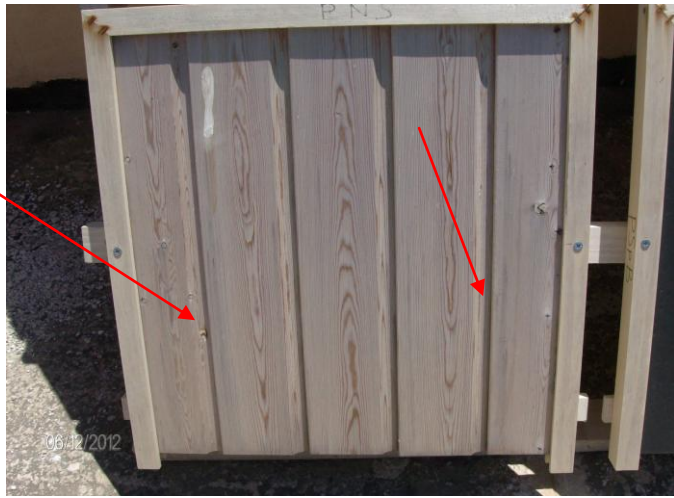
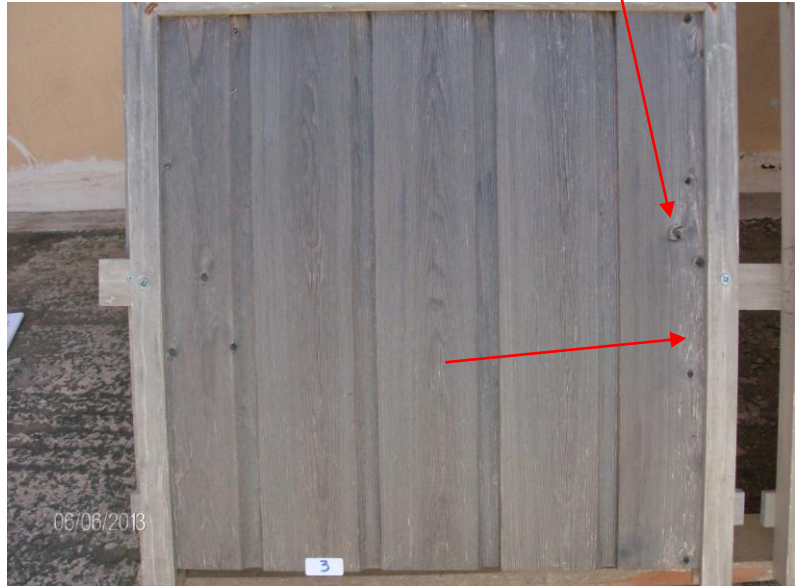
Fig. 7. Cladding 03: XXX Spruce, as in June 2012; The same cladding 03 as in **June 2013**.

Cladding 03 is in a *not good* condition; small checks appearing locally in the surface, while the whole cladding is *very weathered*; extensive *uprising of fibres* exists in the surfaces. Five or six *end checks* have appeared.

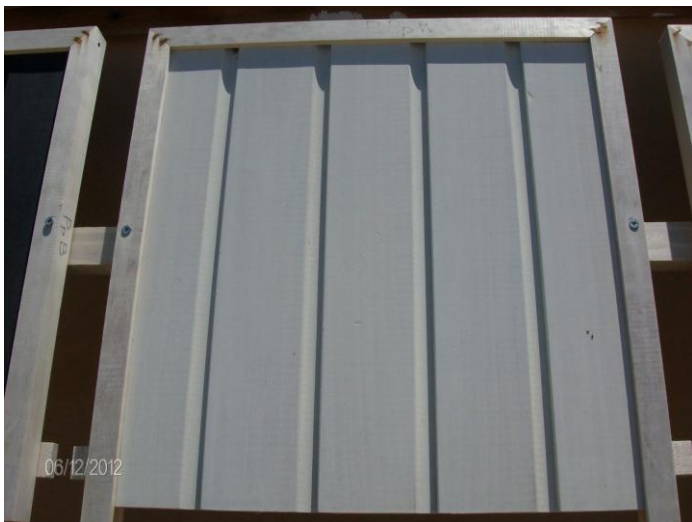
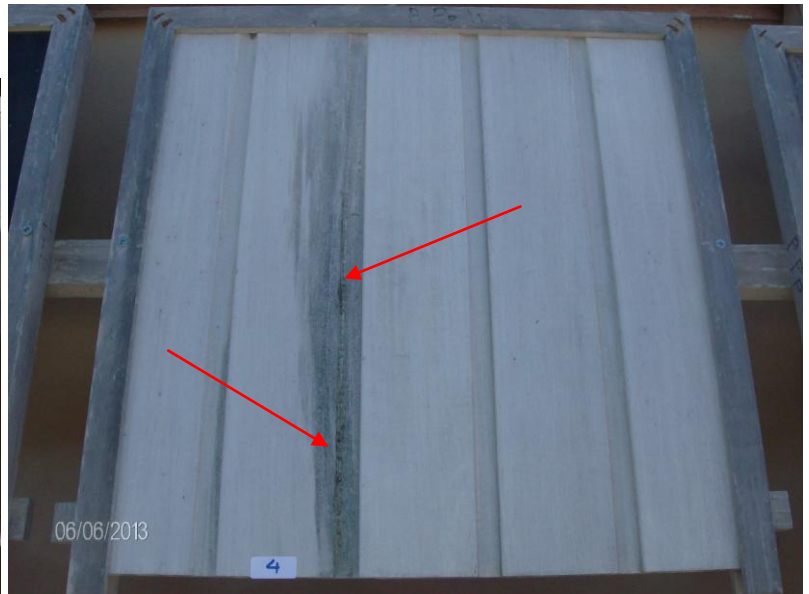
Fig. 8. Cladding 04: XXX Poplar White, as in June 2012; The same 04 as in **June 2013**.

Cladding 04 is aesthetically in *not good* condition; there is a big area (see *red arrows*) with black staining; the white colour is in a *rather good* condition in the rest of the surface; the surface overall is not shiny, as it used to be one year ago (*left photo*). The edges of the cladding no. 04 are *closed well*.

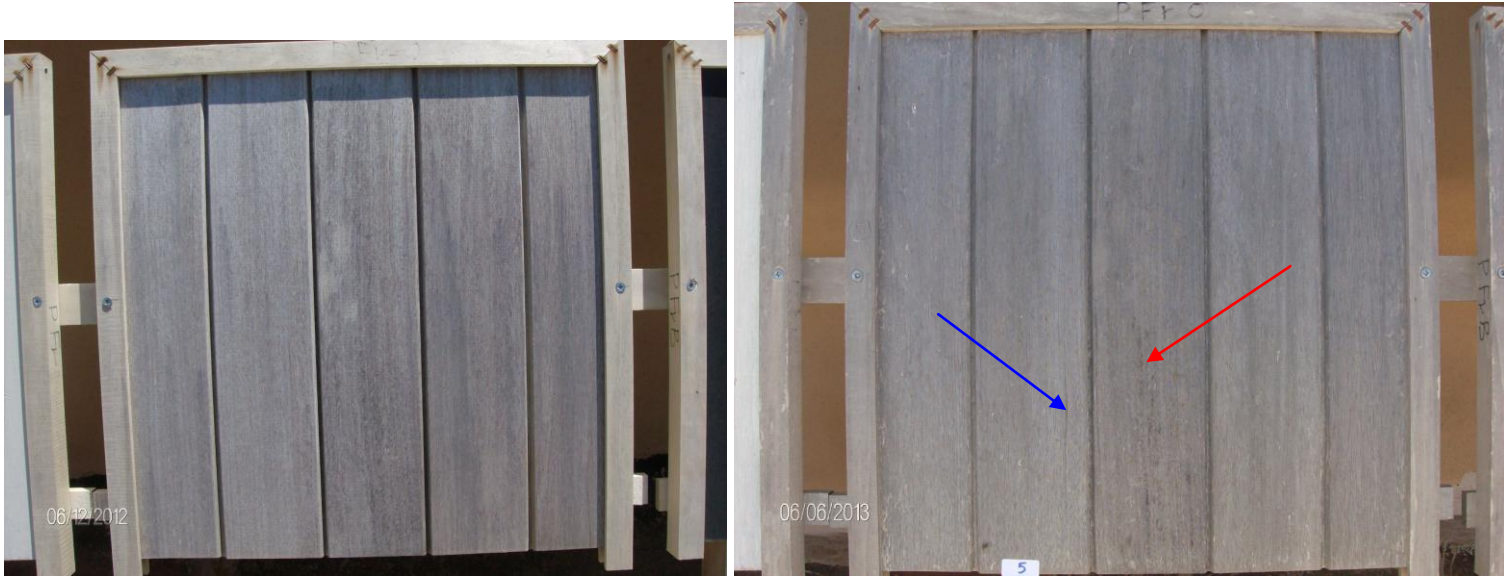
Fig. 9. Cladding 05: XXX Frake, as in June 2012; The same cladding 05 as in **June 2013**.

Cladding 05 is in a *relatively good* condition and is well weathered; the colour is *grey* throughout the surface; some type of *black staining* exists around the surface. Also, 2-3 checks (*blue arrow*) are appearing in it.

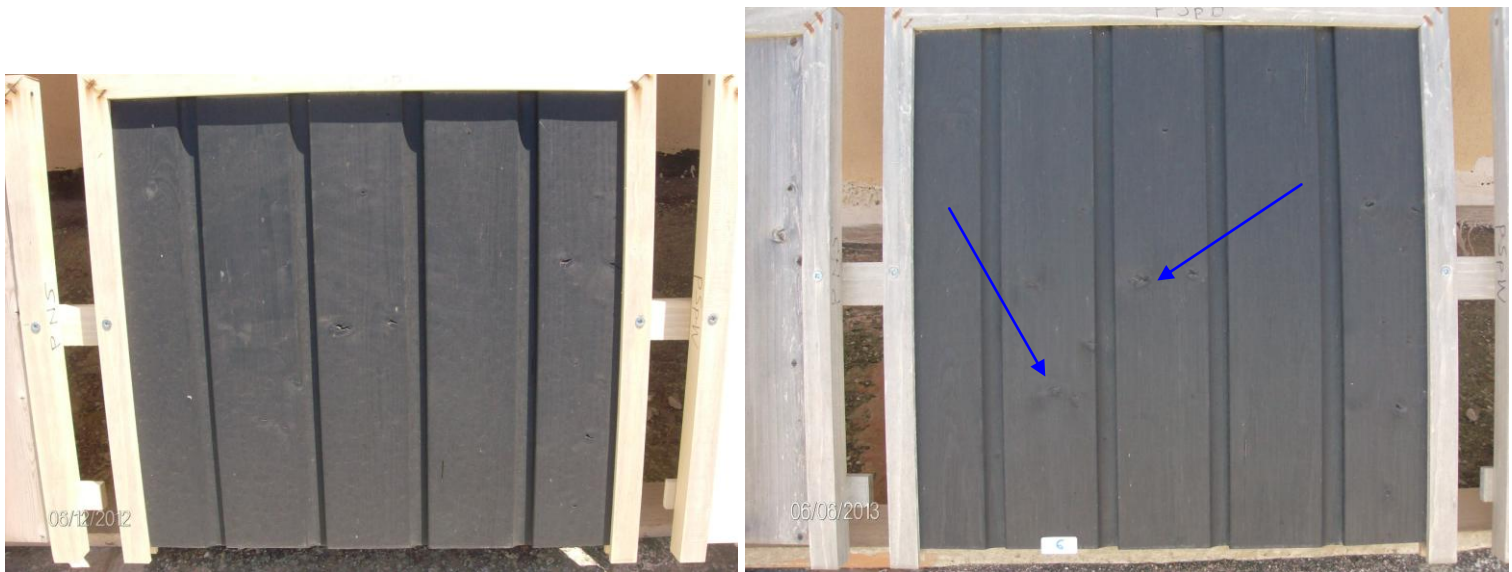
Fig. 10. Cladding 06: XXX Spruce Black, as in June 2012; (right) The same 06 as in **June 2013**.

Cladding 06 is in a *rather good* condition; the surface looks *shiny and clear*; 7-8 minor small cracks appearing; an uprising of a plank is happening. The black colour is all *very stable* throughout and the cladding edges are closed. Possibly this cladding is in the 3rd best condition following no. 08 (XXX Frake Black) and no. 01. The existing (*initial*) few Spruce knots (*blue arrow*) in the cladding appearing to be *unchanged*.

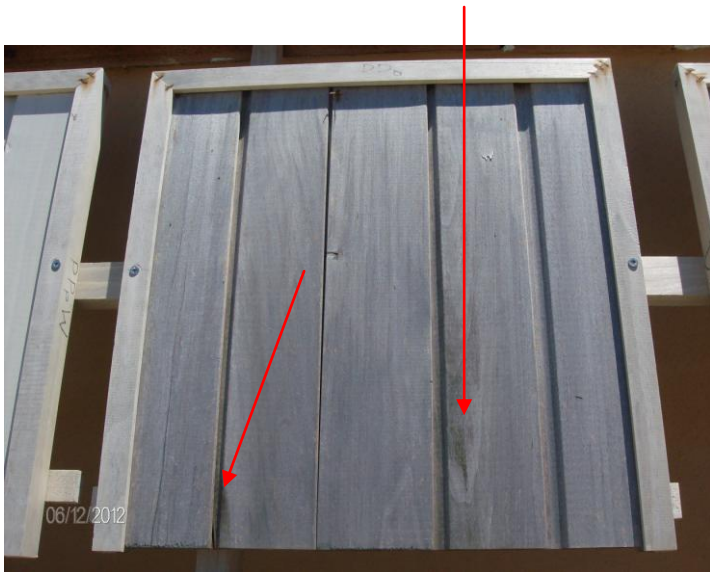
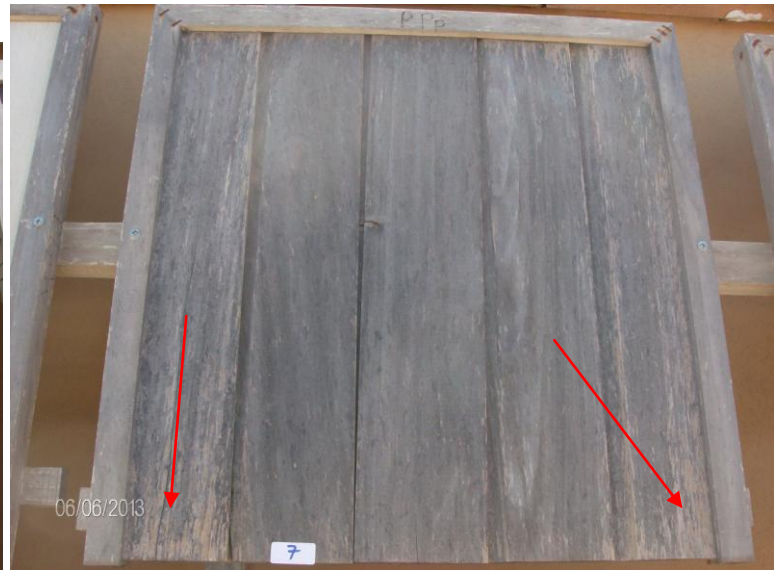
Fig. 11. Cladding 07: XXX Poplar, as in June 2012; (right) The same 07 as in June 2013.

Cladding 07 is in a *bad* condition; the *weathering appearance* is problematic, with many colour fading and surface deterioration; the down edges are quite open and several relatively medium checks are obvious. Several *dark stains* along with some *yellow stains* have appeared locally in the cladding surface.

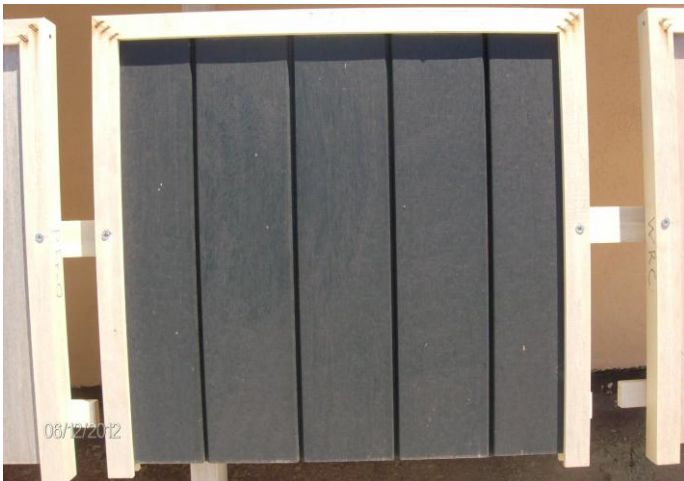
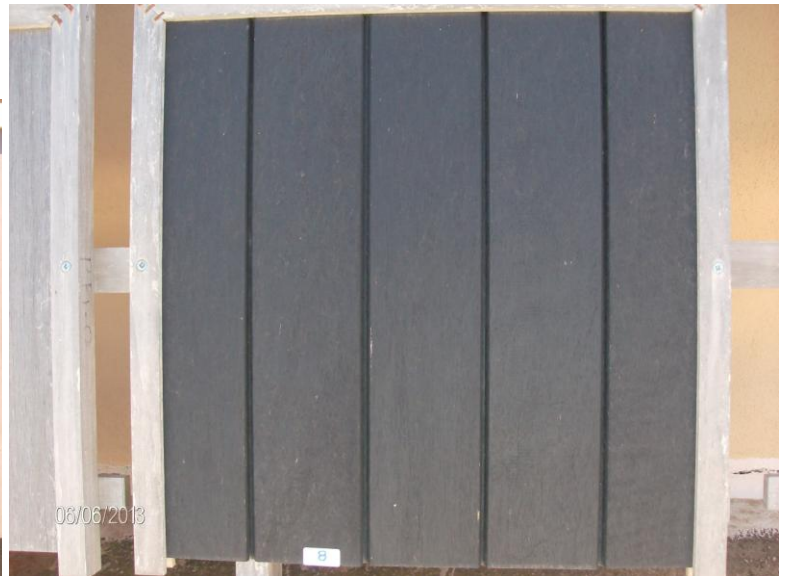
Fig. 12. Cladding 08: XXX Frake Black, as in June 2012; the same (right) no 08 as in June 2013.

Cladding 08 is in an *excellent condition* with a very stable colour after 2 years; obviously no checks, very closed edges. The shiny surface appearance is there! Also, cladding no. 08 is *very stable* in dimensions; with *almost no distortions* along the planks. By naked eye, the best cladding of all so far!

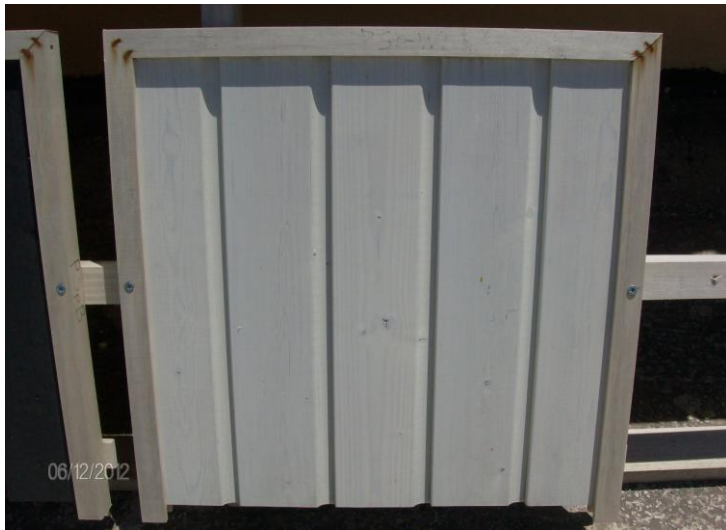
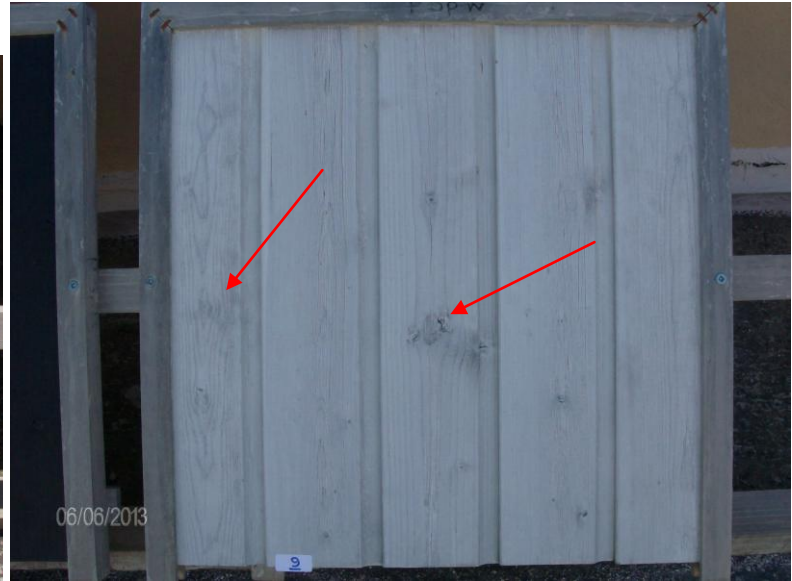
Fig. 13. Cladding 09: XXX Spruce White, as in June 2012; the same no. 09 as in **June 2013**.

Cladding 09 is in a rather medium condition, with a slightly stable white colour. The smooth and shiny surface appearance is not as one year ago; some type of colour fading (red arrows) locally has appeared. The edges of the cladding are quite closed. In no. 09, some small checks start appearing in the surface; with openings in the varnish.

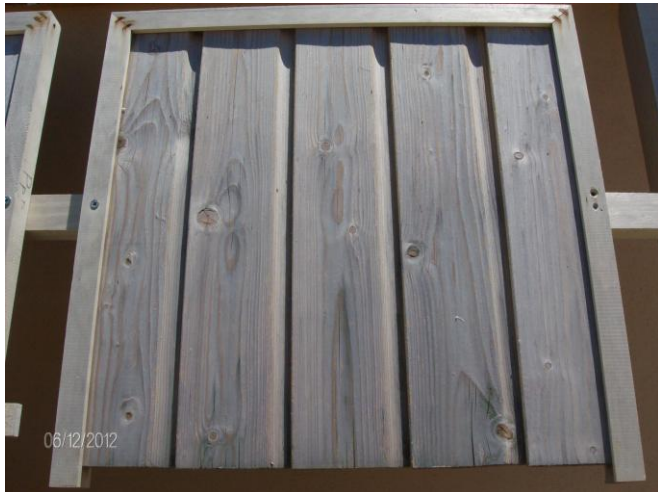
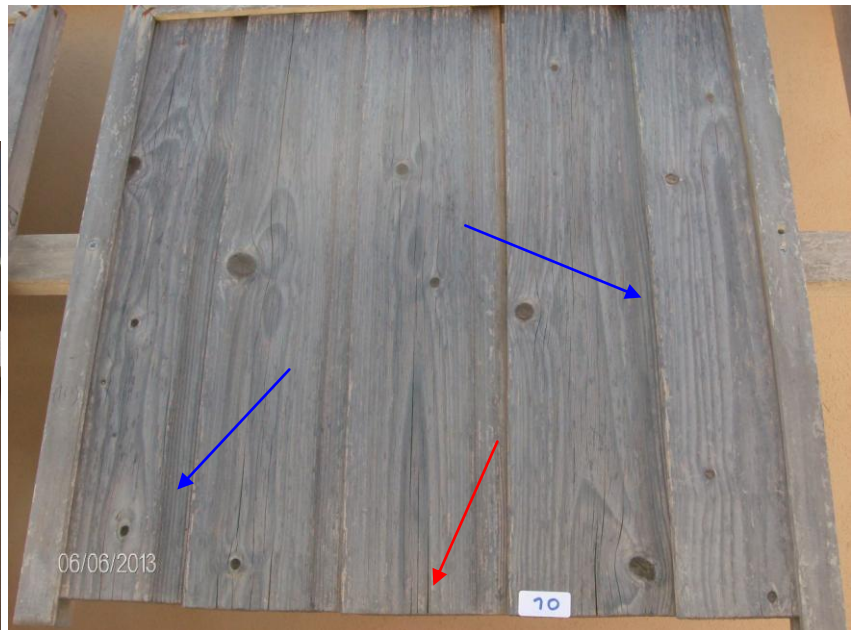
Fig. 14. Cladding 10: Control Spruce, as in June 2012; the same no. 10 as in **June 2013**

Cladding 10 is in the worst condition of all; extensive dark weathering, several large checks (red arrow), big degree of plank distortions (blue arrows), dark stains locally in the surface of this cladding; edge checks are large in 3-4 points; high roughness in the surface. This control cladding looks extremely weathered, and is highly deteriorated.

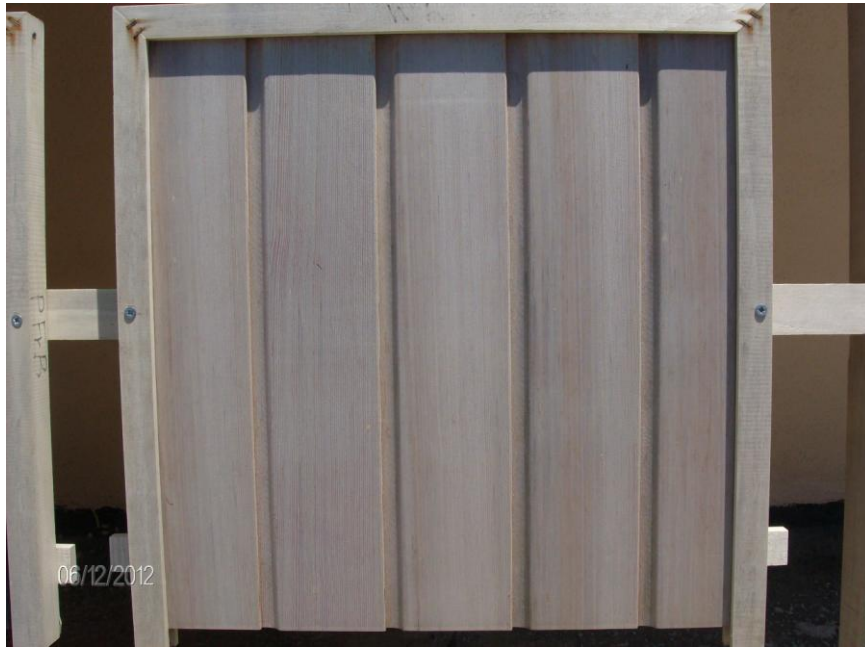
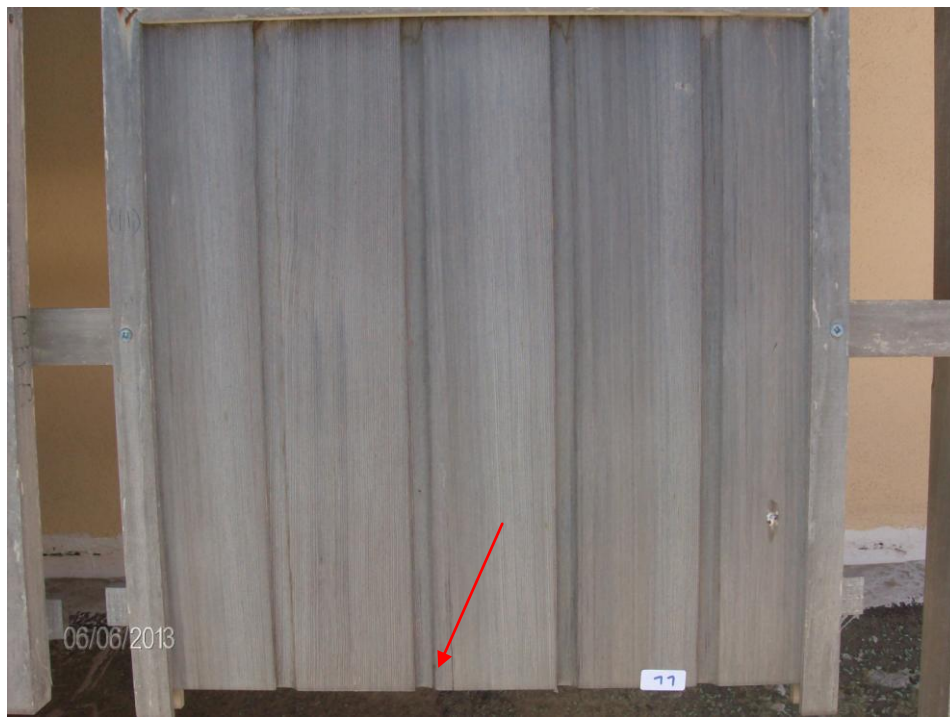
Figs. 15. Cladding 11: Western red cedar (WRC) as in June 2012 (Fig. 15a);
(below) The same cladding no. 11, as in **June 2013** (Fig. 15b)

Cladding 11 is in a good condition, with a stable, light-weathering colour. Obviously it has lost its characteristic cedar colour, as one year ago, having a degree of graying. There are no stains or darkening in the surface; the edges are quite closed and its surface is very smooth! Only, one small edge check has appeared (red arrow).

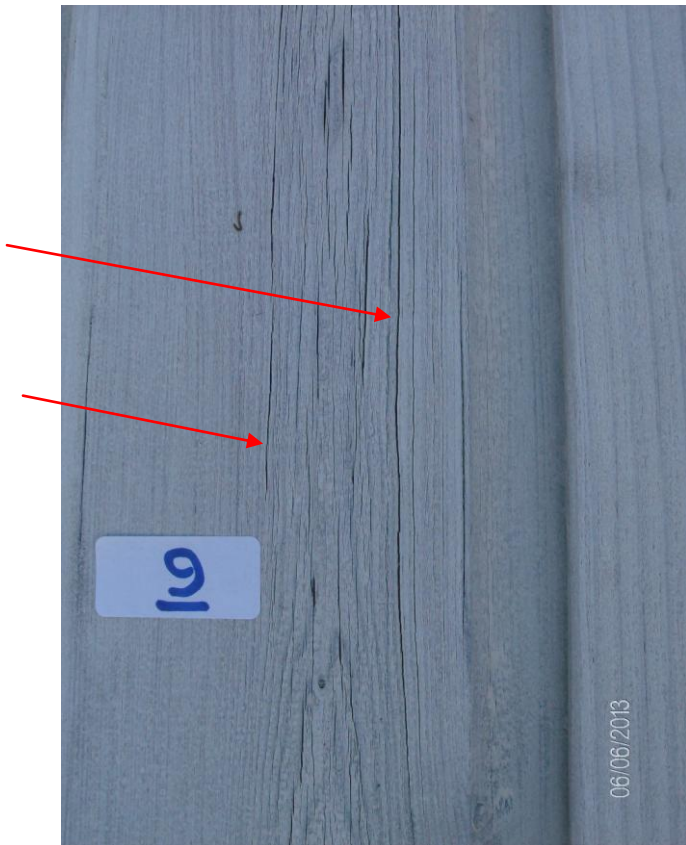
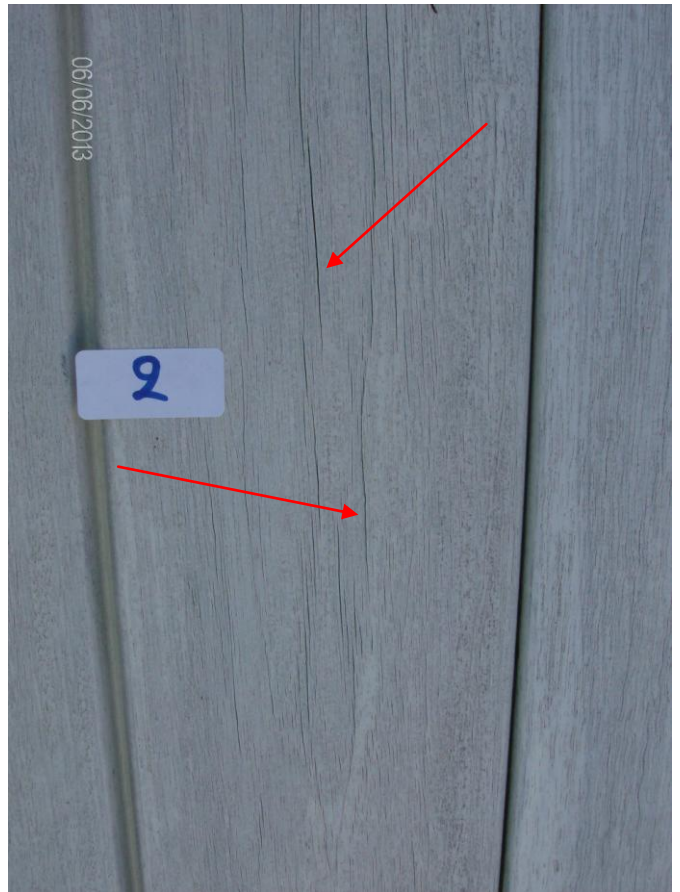
- ✚ Appearance of small cracks and a type of *splitting-up* the *white varnish* did appear in claddings no. 02 and 09 (Figs. 20 & 21). This *cracking* effect will deteriorate, in our opinion. It is like small *openings*.

Figs. 20 & 21. In claddings no. 02 (XXX Frake White) and 09 (XXX Spruce White), small cracks like openings are appearing (in red arrows).

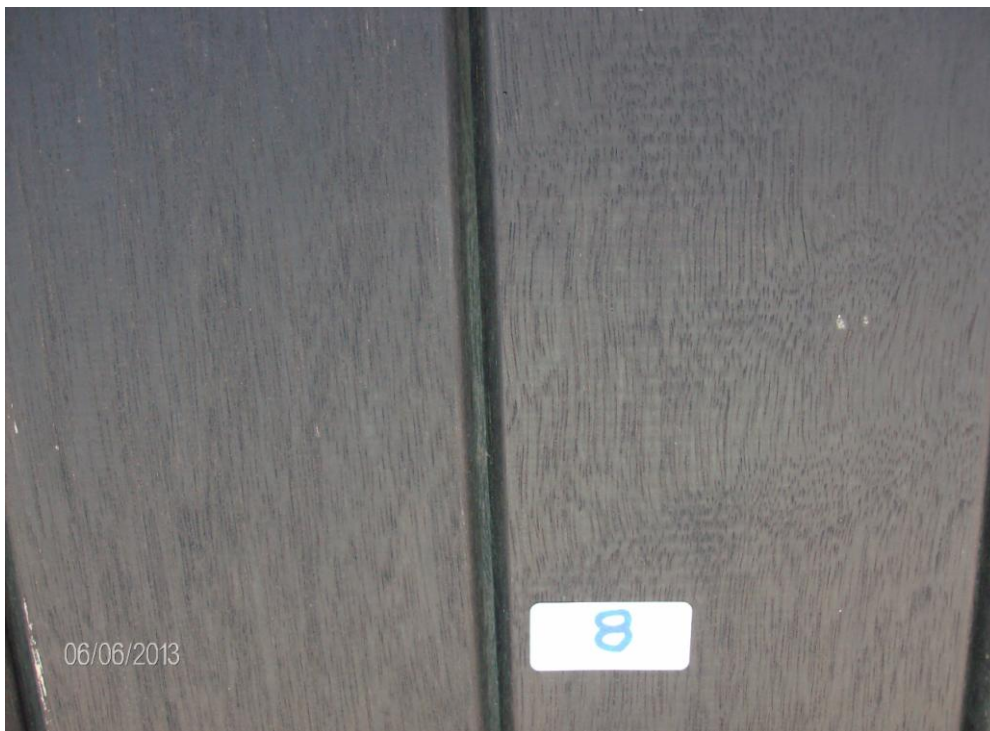
Fig. 22. In cladding no. 08 (XXX Frake Black), no obvious defects appearing in the surface. This cladding surface looks shiny and in an excellent condition.

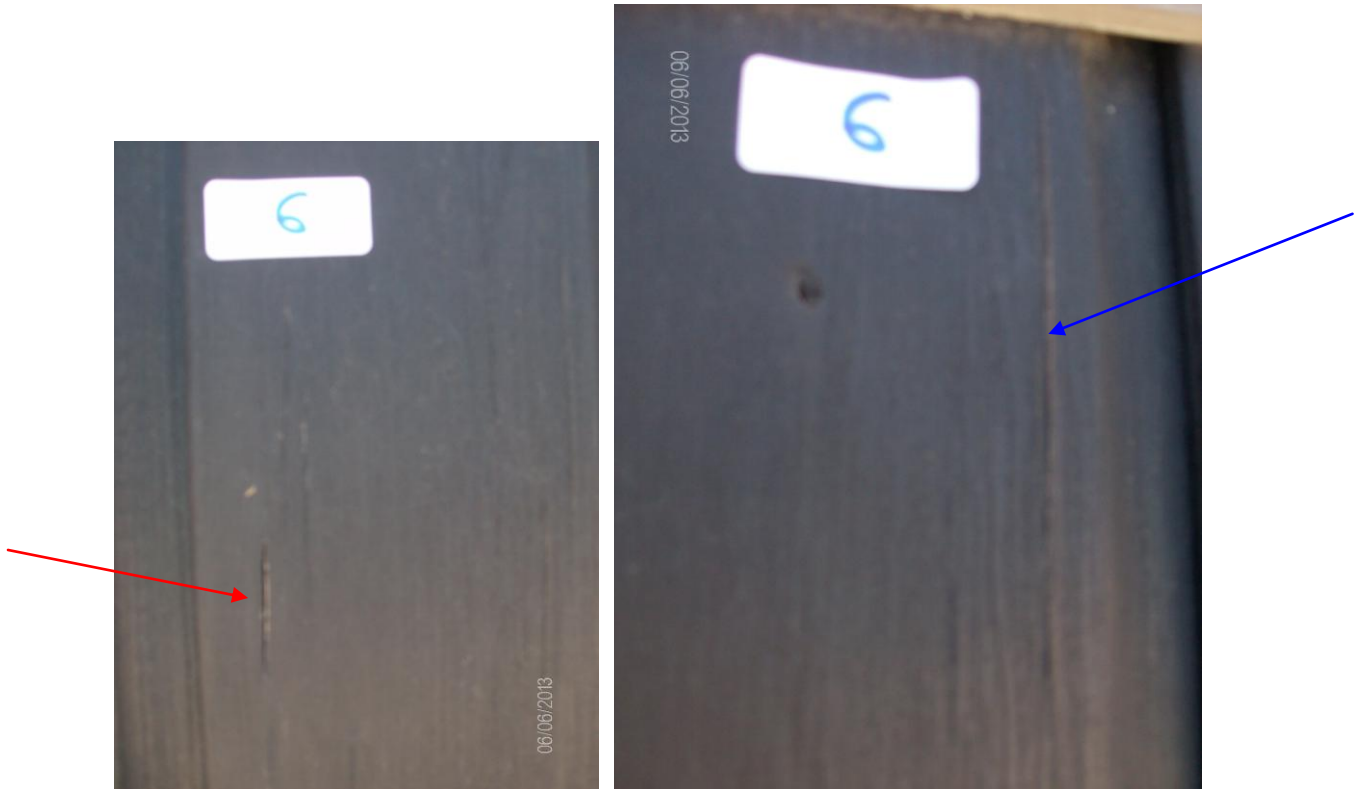
- ✚ Some minor *cracks* have appeared in cladding no. 06 (see Fig. 23). These cracks seem that will be *developed* further as they are like *openings* in the surface.
- ✚ In cladding no. 04 (XXX Poplar White), an extended *black stain* appeared on the surface (see Figs. 24-25). This maybe a *blue stain*.

Fig. 23. In cladding no. 06 (XXX Spruce Black), some cracks were seen (see arrows).

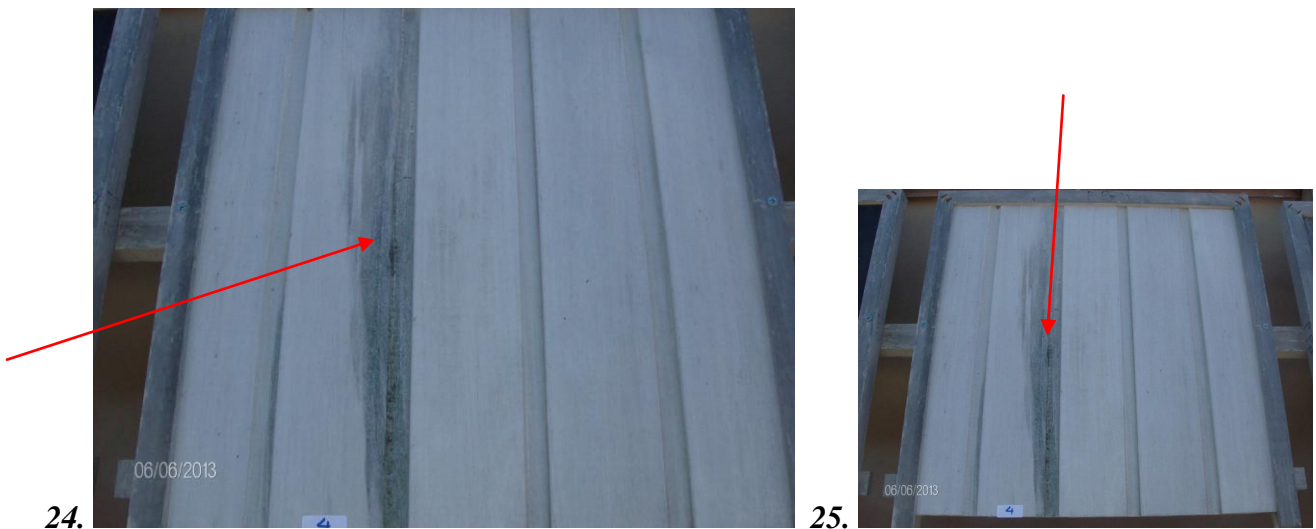
Figs. 24 & 25. In cladding no. 04 (XXX Poplar White), a type of black or blue stain has appeared locally in the surface (in red arrows).

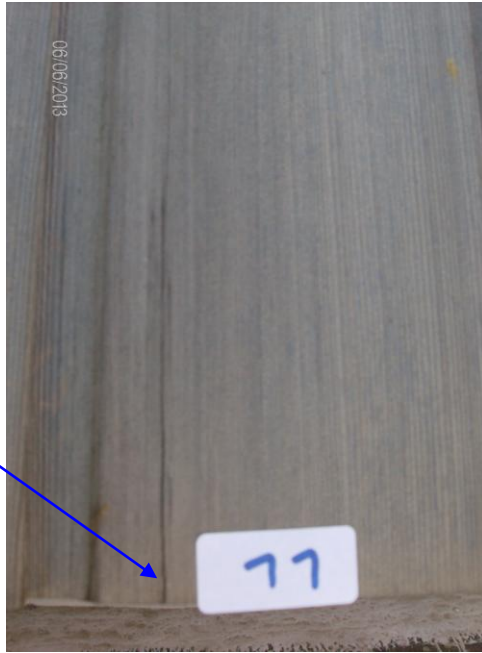
Fig. 26. In cladding no. 11 (Control Western Red Cedar), one small end-splitting was seen.

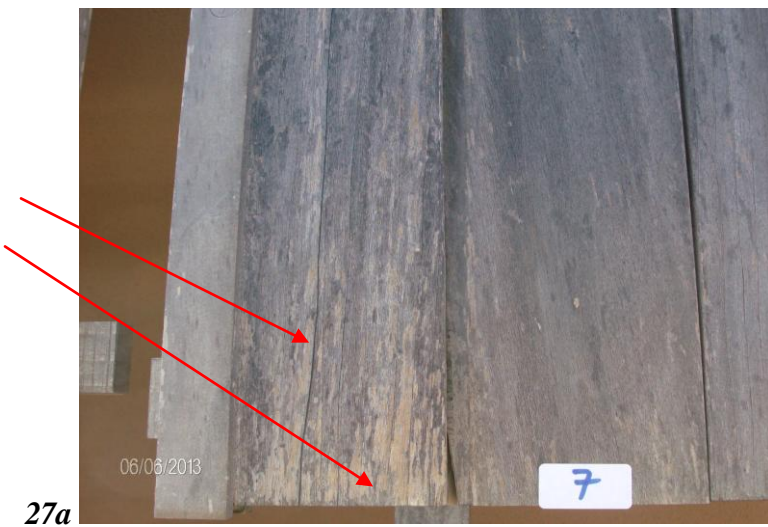
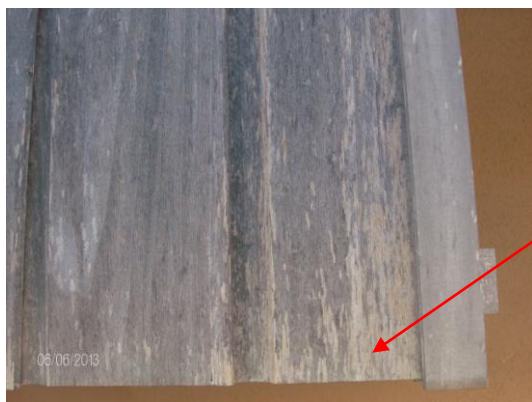
Figs. 27-28. The claddings, no. 07 (XXX Poplar), at left side, and no. 10 (Control Spruce), at right side. In no. 07, an extended weathering appearance and dark & yellow stains. In control no. 10 cladding, the appearance is the worst of all, with lots of defects: cracks, openings, dark stains, extended weathering colour, etc.

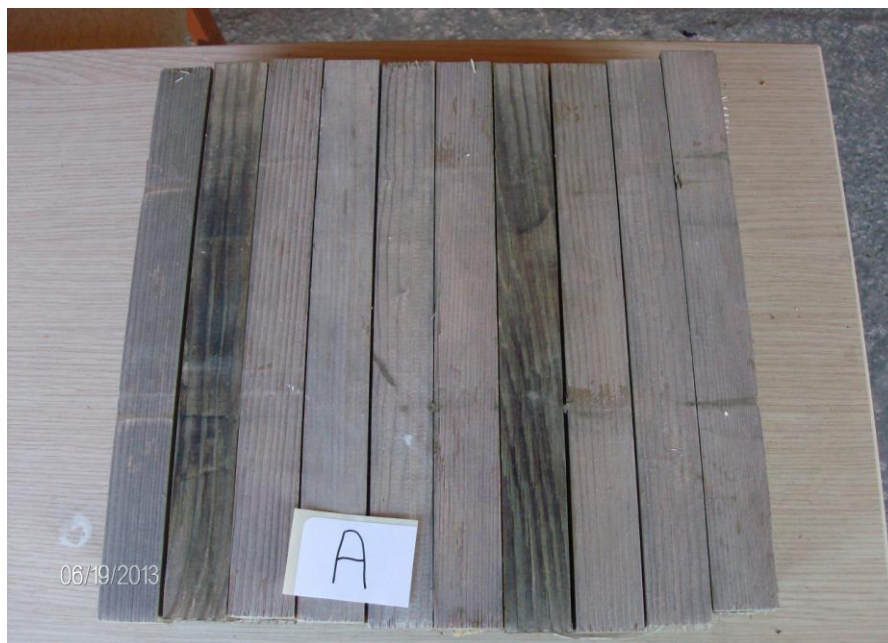
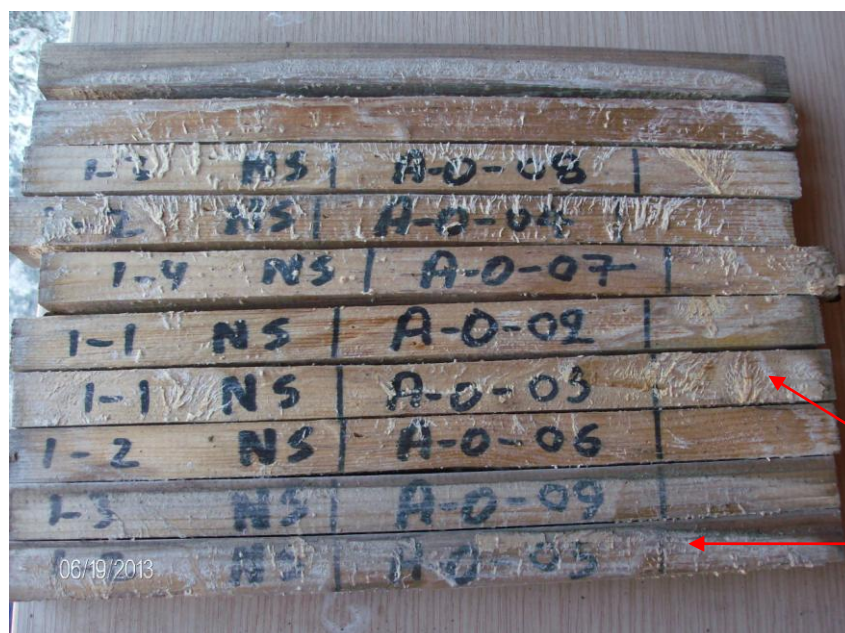
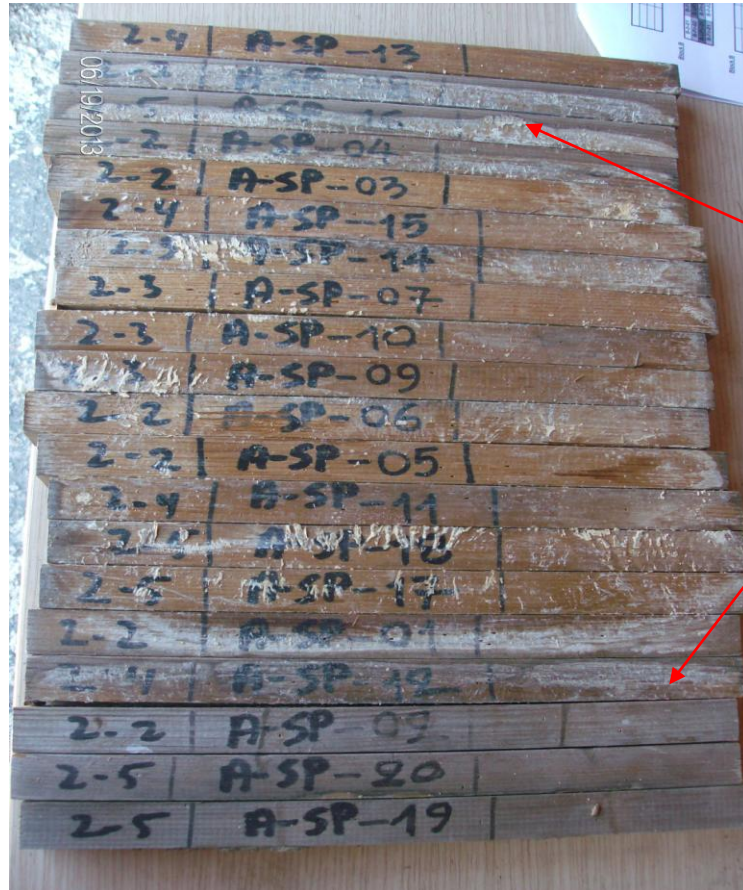
First, the general appearance of **Block A** (Fig. 29a) looked *rather good*. The testing stakes, namely *A-Sp*, looked *slightly attacked* with visible signs of decay but still solid. The *Spruce feeders* namely *A-0* (Fig. 29b) had a larger fungal attack. The batch of control *Pine sapwood* (*A-Pi*) had been suffered a *severe attack* in overall. Some *A-Pi* stakes were close to the point of *total failure*.

Fig. 29 a-b-c. Appearance of block A, as seen in June 2013.

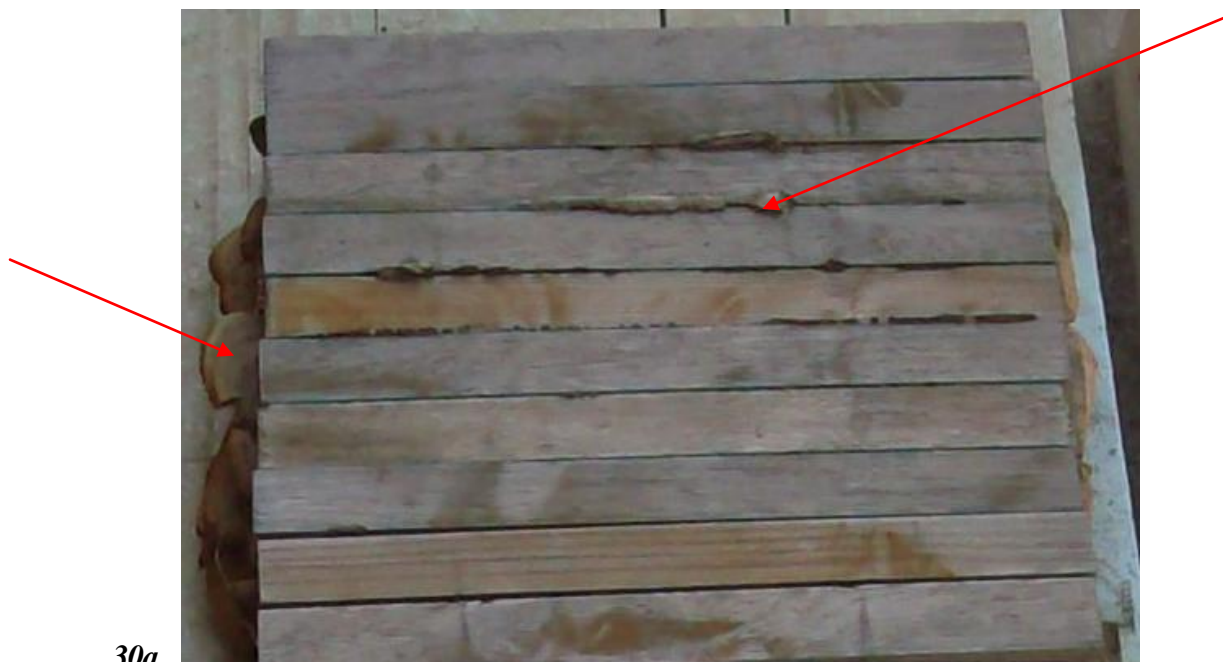
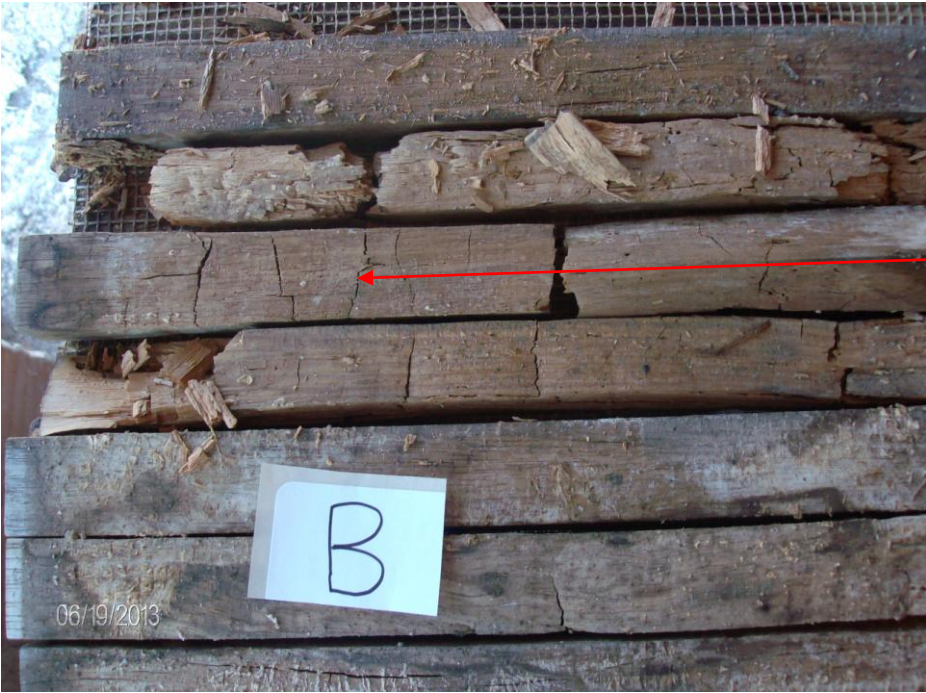
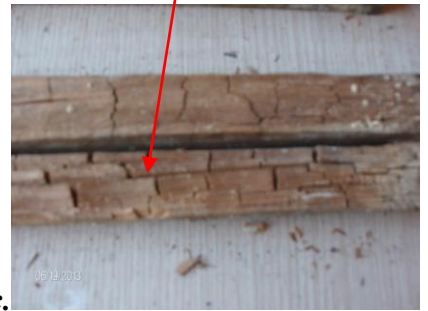
Second, the appearance of **Block B** was that as seen in Figs. 30a-b-c. The general appearance of block B was *very bad*. The testing materials (namely *B-Fr*) looked under a *moderate* fungal attack. The batch *B-0* with material of *Spruce* feeders and the batch *B-UFr* (with *untreated Frake* stakes) had suffered *very severe attack* in general. Many stakes (approx. 6 + 8, respectively) had a *total failure* and had been collapsed (see details in Figs. 30 b-c).

Fig. 30 a-b-c. Appearance of block B, as seen in June 2013.

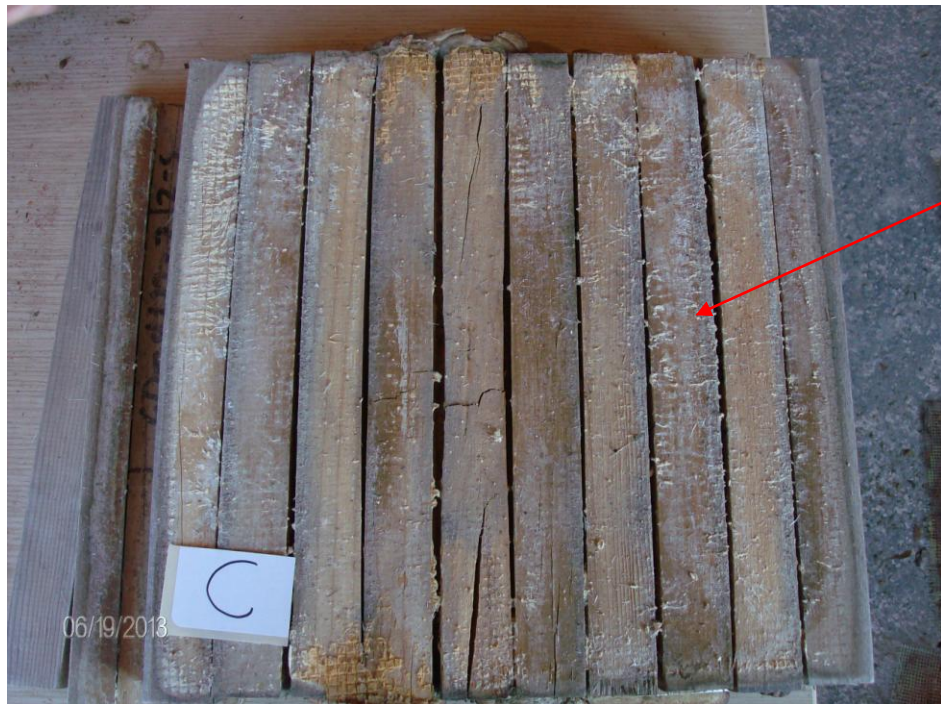
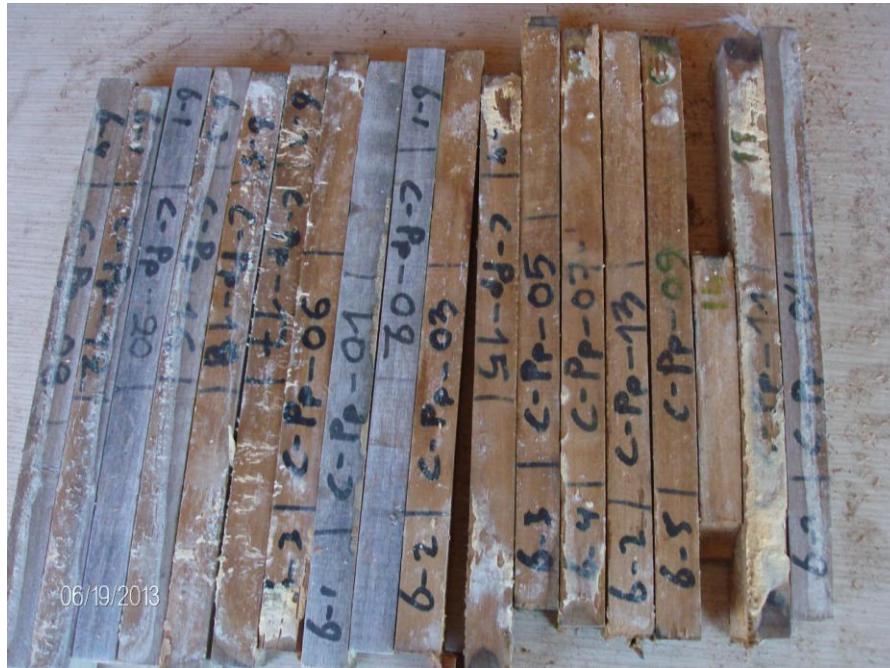
Fig. 31 a-b. Appearance of block C, as seen in **June 2013**.

Third, the appearance of **Block C** was that as seen in Figs. 31a-b. Apparently, the general appearance of this block was **rather good**. The testing materials (namely *C-Pp*) looked *good*, with a *slight* fungal attack. The *C-0* materials, *Spruce feeders*, had a *slight to moderate* attack, while the batch of *untreated Poplar* (namely *C-UPp*) had a similar *slight to moderate* attack. This was really interesting for the *untreated Poplar* stakes: we should note this result as a *rather unexpected* finding for *poplar* wood.
