████████████████████
Evaluation report (24-month report)

Testing of ██████████ products in a 3- year outdoor exposure in Greece using cladding- and block- tests

Research Committee, TEI of Thessaly (former Larissa)
Project no. 3749

KARDITSA, GREECE (June 2013)

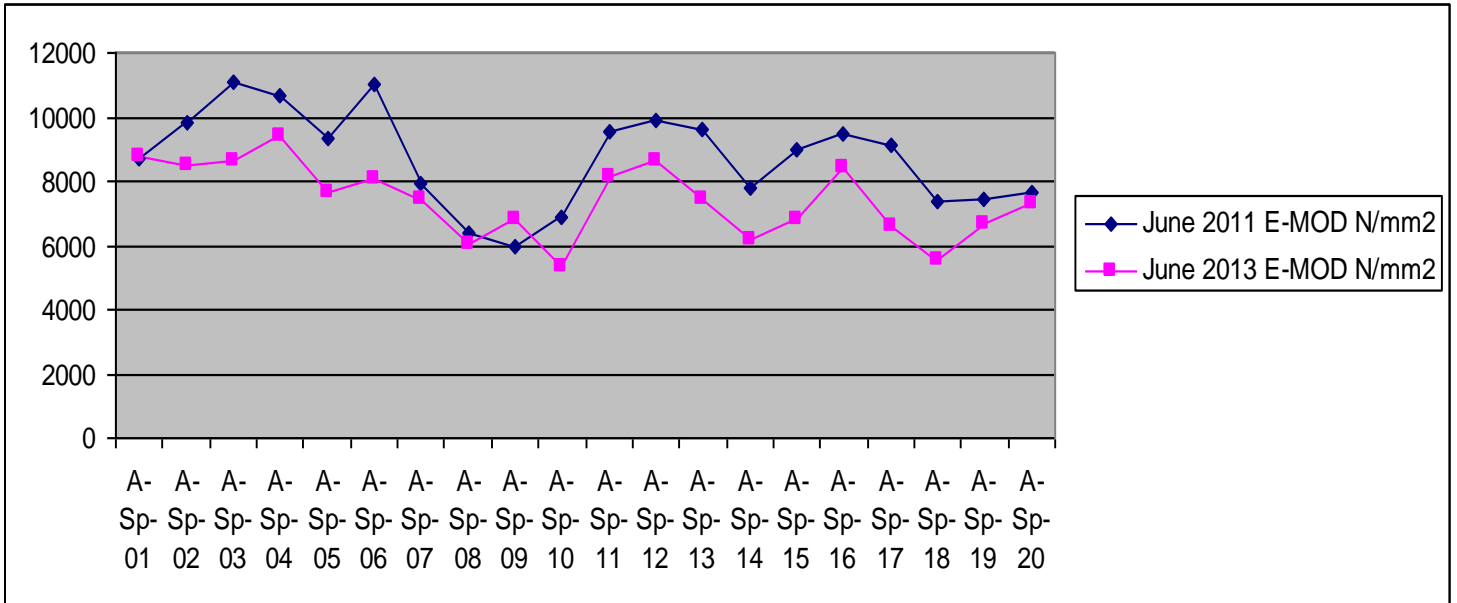
Fig. 33a. Block A: dyn. MOE values for *XXX Spruce* stakes in the period 06/2011 - 06/2013

Apparently in “**Block A**”, from the Figs. 33, we can conclude: a) there is a small ~15% drop in the dynamic MOE properties in the *A-Sp* stakes (*XXX Spruce*) measured (Fig. 33a), b) there is *dramatic* decrease in MOE in the *control untreated Pine sapwood* stakes (Fig. 33b); only 5 measured, while the rest found close to zero, that is, it *was not* possible to measure, and c) for the feeder samples, *untreated Spruce*, only six (6) stakes were possible to be measured with the *Grindosonic* device, showing thus a *rather large* drop in the dynamic MOE values.

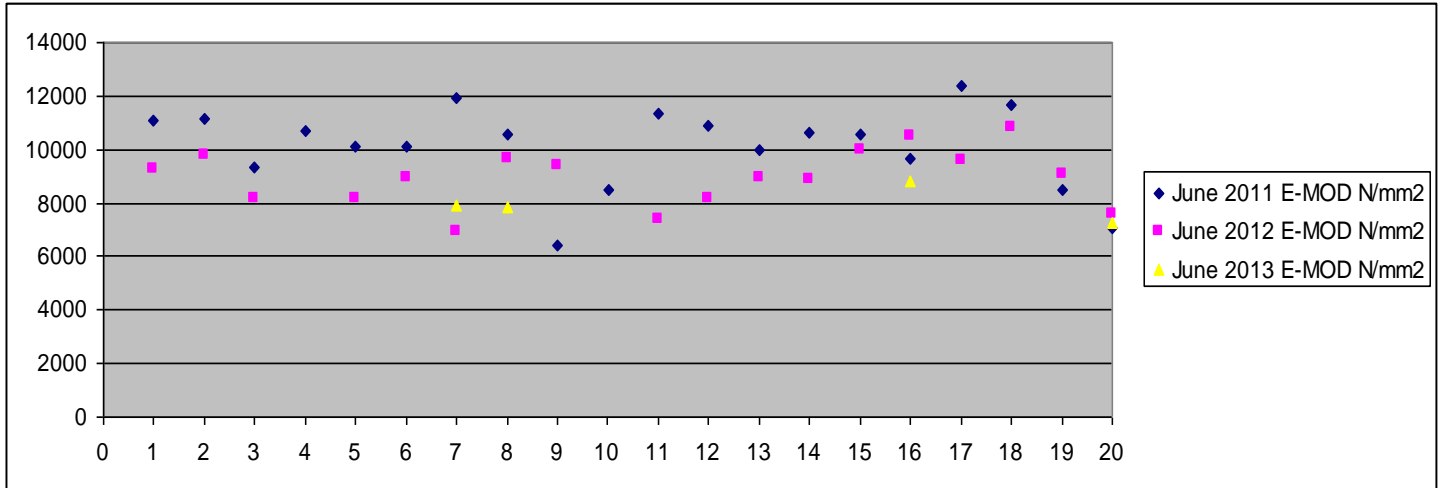
Fig. 34a. Block B: dyn. MOE values for *XXX Frake* in the period 06/11 - 06/12 - 06/13

Then, in “**Block B**”, from the Figs. 34, we can conclude: a) there was possible to measure dyn. MOE properties in only 4 *B-Fr* stakes (*XXX Frake*) (Fig. 34a); b) there was *very dramatic* decrease in MOE in the *control untreated Frake* wood stakes (Fig. 34b); almost all stakes had MOEs close to zero, that is, it was *not* possible to measure due to obvious *failure*, and c) for the feeder samples, *untreated Spruce*, only three (3) stakes measured close to 1.000 N/mm² with the *Grindosonic* device; the rest zeroed.

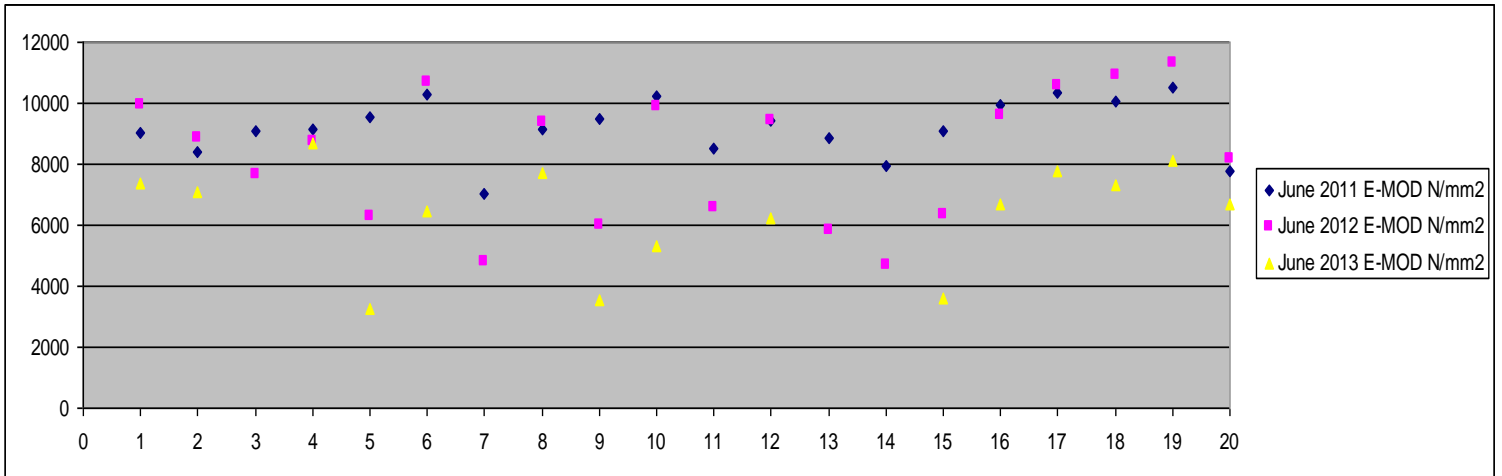
Fig. 35a. Block C: dyn. MOE values for *XXX Poplar* in the period 06/11-06/12-06/13

Apparently in “**Block C**”, from the Figs. 35 above, we can conclude: a) there is a >30% drop in the dynamic MOE properties in the *C-Pp* samples (*XXX Poplar*) measured (Fig. 35a), b) there is *very large* decrease in MOE in the *control untreated Poplar* stakes (Fig. 35b); most measurements were close to zero, that is, it *was not* possible to measure, and c) for the feeder samples, *untreated Spruce*, only five (5) measurements were possible to realise with the *Grindosonic* device, showing thus a *very large* drop in the dynamic MOE values.
